# UNDERWATER BRIDGE INSPECTION REPORT

STRUCTURE NO. 58525

KETTLE RIVER

DISTRICT 1 - PINE COUNTY

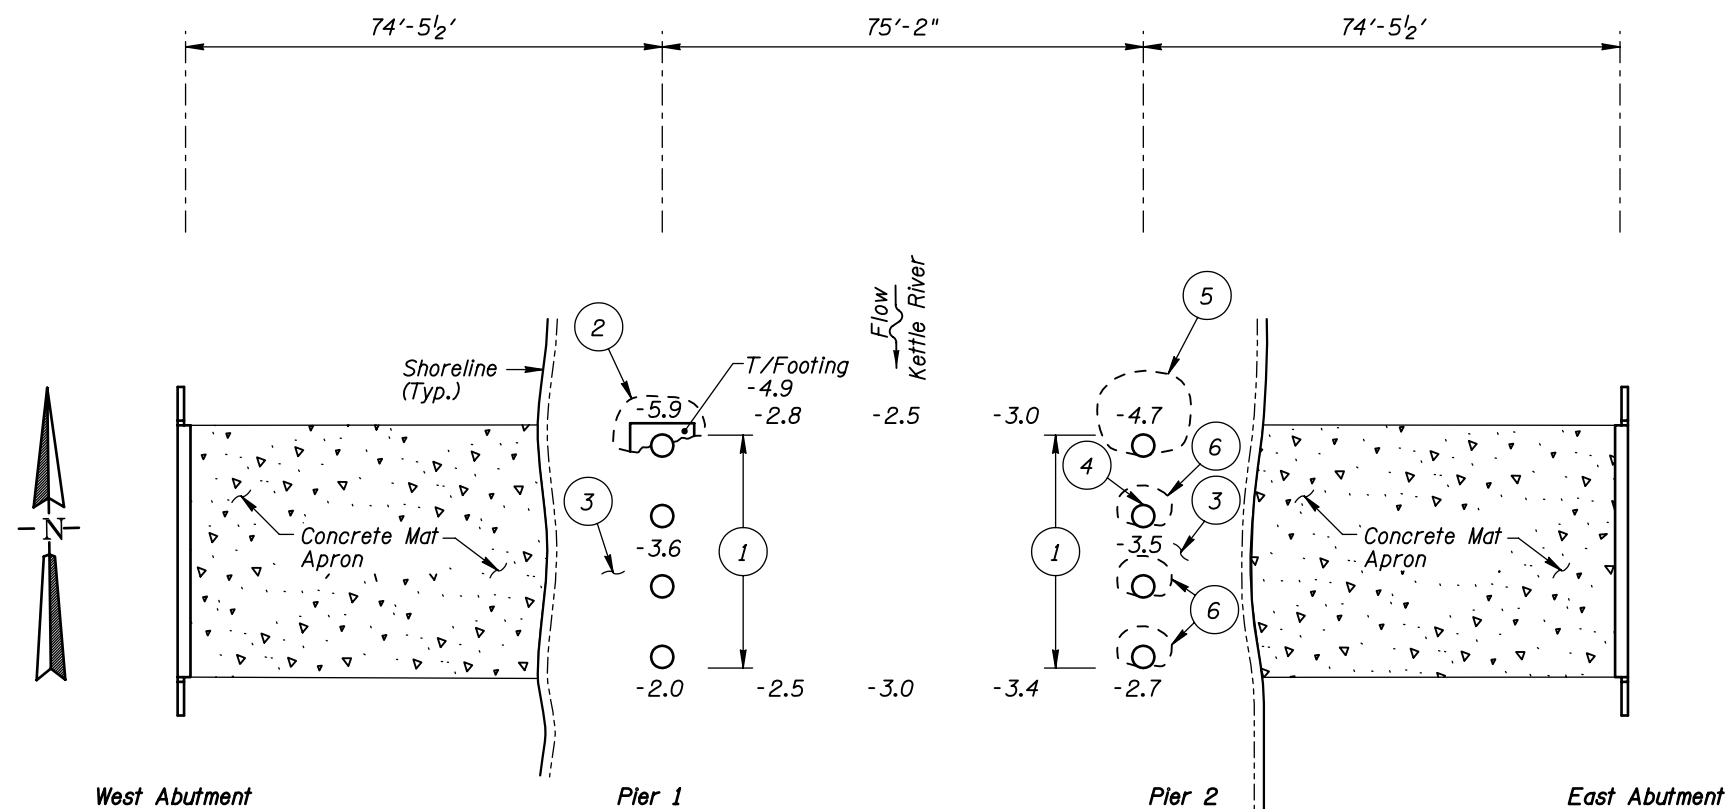
**INSPECTION AND SOUNDING PLAN**

- The concrete columns exhibited light scaling from the waterline to 1 foot below the waterline with up to 1/8 inch penetrations.
- A scour depression, measuring 3 feet in radius and 1 foot deep, was observed at the upstream end of Pier 1. The scour depression has exposed the top of the footing at the upstream end of the pier with no vertical face exposure.

- The channel bottom consisted of sandy gravel with cobbles up to 6 inches in diameter.
- An area of poorly consolidated concrete was observed 3 feet above the waterline and measured 2 foot high by 1 foot wide with up to 1.5 inches of penetration.

- A scour depression, measuring 6 feet in radius and 2 foot deep, was observed at the upstream end of Pier 2. Scattered 1 foot diameter riprap was observed in the scour depression.

- Scour depressions, measuring 1.5 feet in radius and 1 foot deep, were observed at each of the three downstream columns of Pier 2.

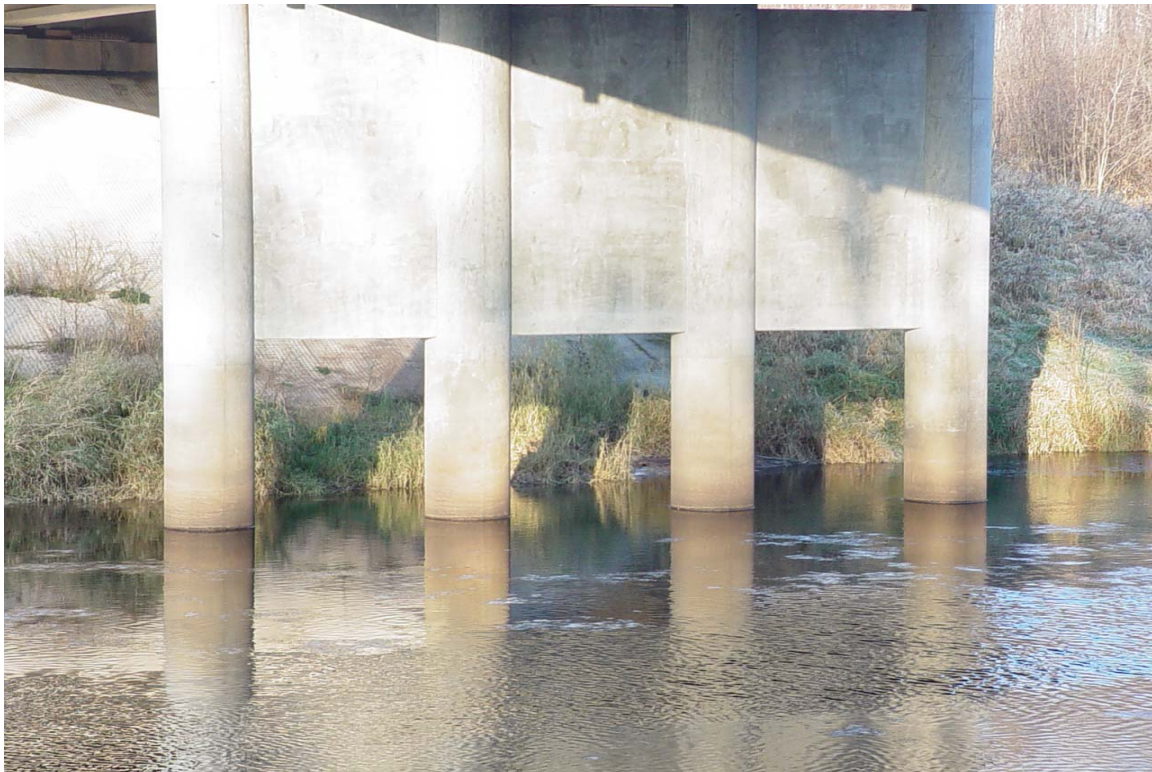
- (A) The concrete columns exhibited light scaling from the waterline to 1 foot below the waterline with up to 1/8 inch of penetration.
- (B) A scour depression, measuring 3 feet in radius and 1 foot deep, was observed at the upstream end of Pier 1. The scour depression has exposed the top of the footing at the upstream end of the pier with no vertical face exposure observed.

Photograph 2. View of Pier 1, Looking Northwest.

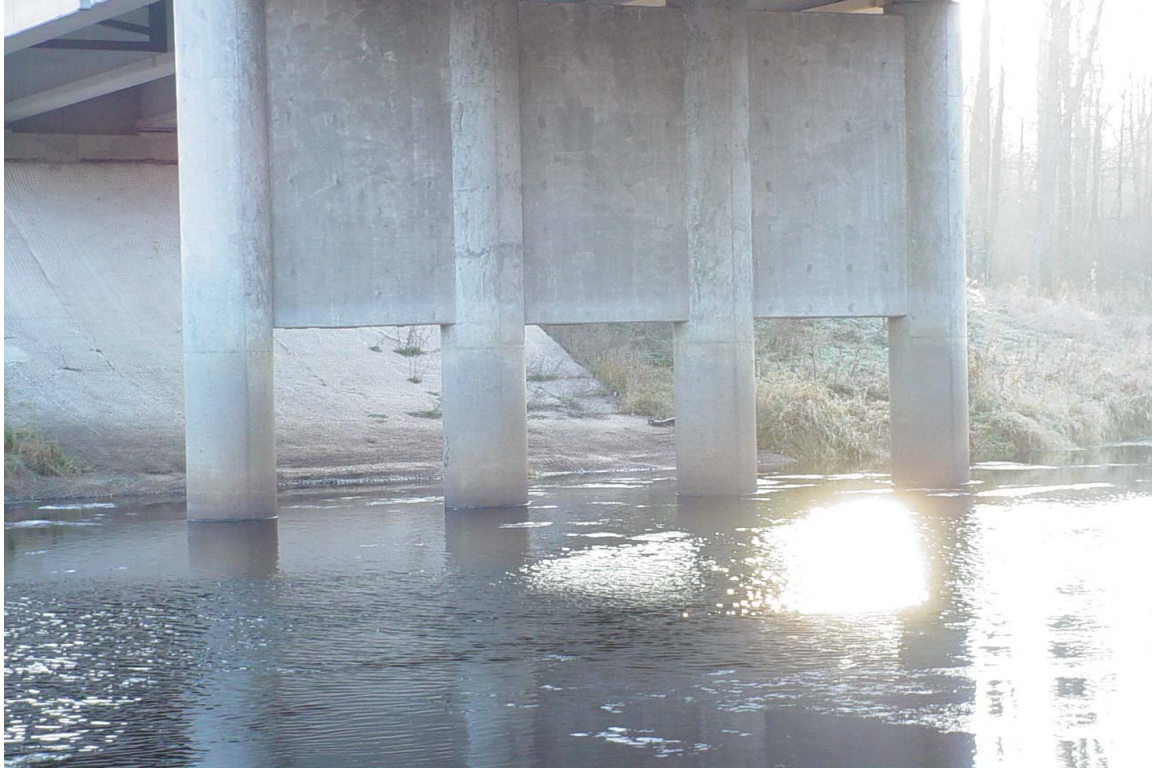
- (C) A scour depression, measuring 6 feet in radius and 2 foot deep, was observed at the upstream column of Pier 2 with scattered 1 foot diameter riprap in the bottom of the depression. In addition, scour depressions, measuring 1.5 feet in radius and 1 foot deep, were observed at each of the three downstream columns of Pier 2.

- (D) An area of poorly consolidated concrete was observed 3 feet above the waterline on the second column from the upstream end of Pier 2 and measured 2 foot high by 1 foot wide with up to 1.5 inches of penetration.

Photograph 3. View of Pier 2, Looking Southeast.
